Analysis of Hex Cap Fasteners

Revealed Dimensional Related Failure Causation

by Keith Bailey

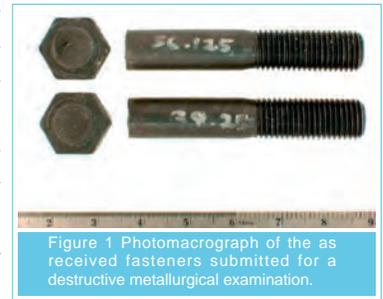
This paper discusses the metallurgical failure analysis of two L9 grade hex cap fasteners which failed to meet the requirements associated with section 3.5.1 of ASTM F 606 (Figure 1). These non-compliant test results lead to the metallurgical analysis to determine the likely cause of the failures at the radius transition between the head and shank features. This destructive metallurgical investigation included a macroexamination, fractography, chemical analysis of the base alloy, microexamination, hardness evaluation and mechanical testing.

Figure 1 Photomicrograph of the as received fasteners submitted for a destructive metallurgical examination.

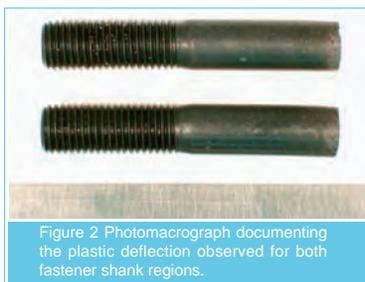
Initial examination of the submitted fasteners revealed both to exhibit plastic deformation/deflection in the shank region consistent with a wedge type test similar to that discussed in ASTM F 606 (Figure 2). Evaluation of the load bearing surface of both heads also revealed localized plastic

Figure 2 Photomicrograph documenting the plastic deflection observed for both fastener shank regions.

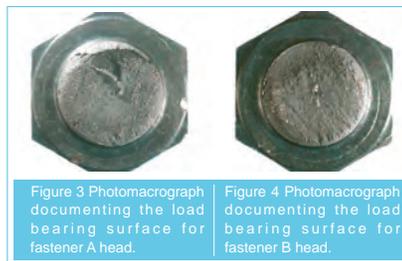
deformation consistent with that of a wedge type mechanical test (Figures 3 and 4). Evaluation of the fracture and other regions revealed no instances consistent with manufacturing defects or surface discontinuities such as those discussed in Section 3 of SAE J 123

Figure 3 Photomicrograph documenting the load bearing surface for fastener A head.

Figure 4 Photomicrograph documenting the load bearing surface for fastener B head.

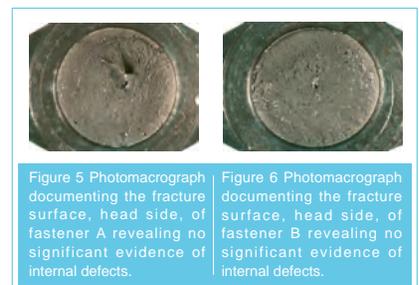
(Figures 5-8). These include but are not limited to the lack of fracture surface defect features such as voids, internal cracks, forging flow line re-entry, relatively large inclusions/oxides and evidence of quench cracking. This also includes but is not limited to the lack of observations of the following surface discontinuities: quench cracks, seams,

Figure 5 Photomicrograph documenting the fracture surface, head side, of fastener A revealing no significant evidence of internal defects.

Figure 6 Photomicrograph documenting the fracture surface, head side, of fastener B revealing no significant evidence of internal defects.

bursts, shear burst, voids, laps, folds, appreciable tooling marks, significant nicks or gouges. Analysis of the failure surfaces revealed the presence of a shear lip at both the fracture initiation and final failure locations for each

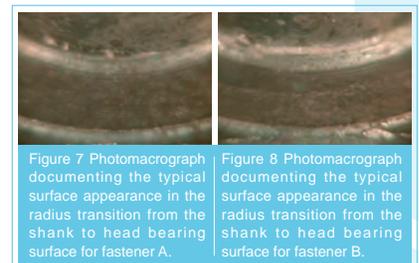
Figure 7 Photomicrograph documenting the typical surface appearance in the radius transition from the shank to head bearing surface for fastener A.

Figure 8 Photomicrograph documenting the typical surface appearance in the radius transition from the shank to head bearing surface for fastener B.

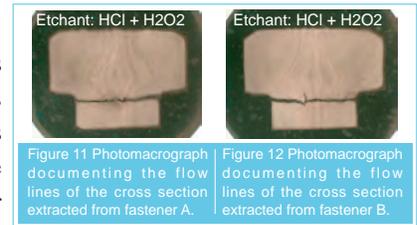
Results of this analysis revealed the flow line of each fastener cross section to exhibit no evidence of re-entry or laps (Figures 11 and 12).

Figure 11 Photomicrograph documenting the flow lines of the cross section extracted from fastener A.

Figure 12 Photomicrograph documenting the flow lines of the cross section extracted from fastener B.

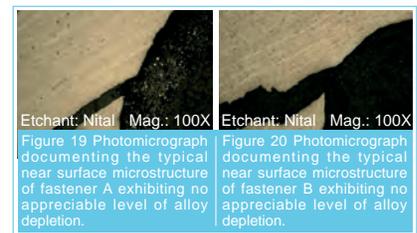
Examination of both cross sections revealed no appreciable presence of an oxide layer to be present in the failure initiation regions (Figures 13 and 14). These cross sections exhibited no evidence of a significant level of precipitates/oxides in the head or shank locations. Evaluation of the cross sections in the etched condition revealed the initial fracture of the fasteners to follow the flow lines of the microstructures (Figures 15 and 16). Both fastener cross sections revealed a martensitic matrix and a small percentage of apparent ferrite (Figures 17 and 18). Evaluation of the near surface regions revealed no etch effects suggesting an appreciable level of decarburization or other alloy depletion to be present (Figures 19 and 20).

Figure 19 Photomicrograph documenting the typical near surface microstructure of fastener A exhibiting no appreciable level of alloy depletion.

Figure 20 Photomicrograph documenting the typical near surface microstructure of fastener B exhibiting no appreciable level of alloy depletion.
